# REPORT

SL 2013/06

REPORT CONCERNING AVIATION ACCIDENT ON  
THE CAPE HEER HELIPORT, SVALBARD,  
NORWAY, 30 MARCH 2008 WITH MIL MI-8MT,  
RA-06152, OPERATED BY SPARK+ AIRLINE LTD.

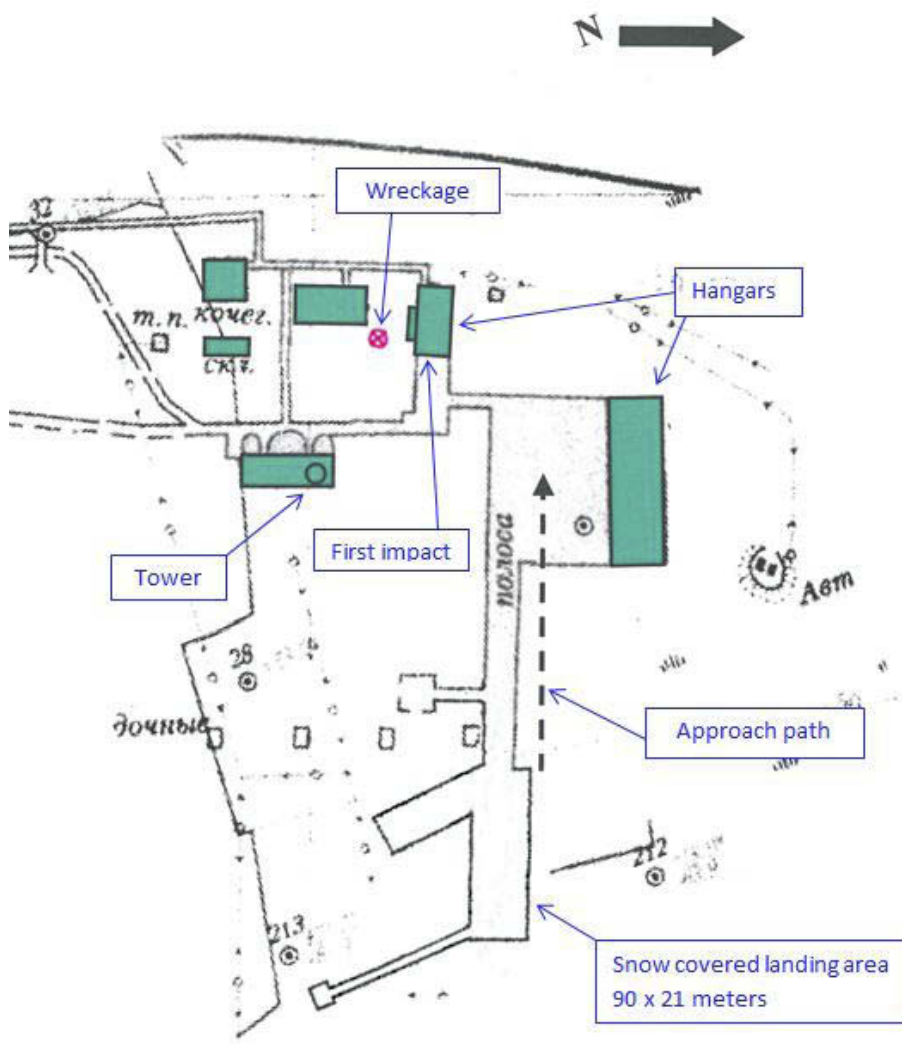
Figure 1: Drawing of the heliport.

- 1.10.3 During the inspection in 2007, the Civil Aviation Authority identified several nonconformities in relation to regulatory requirements described in Norwegian Civil Aviation regulations (BSL) D, E and G. The nonconformities included that the manoeuvring area was poorly cleared of snow and hard to see. There were comments relating to insufficient marking of the landing area (FATO/TLOF) and obstacles in the approach from the west.

1.12.1.3 The 12-metre tall hangar is approx. 100 metres from the intended landing site. The point of impact on the hangar corresponded to a sideways movement to the left of 75 metres or a change in course of approx. 50° to the left in relation to the straight approach path of 270° followed by the helicopter. The gap between the two hangars was 88 metres (see Figure 1).

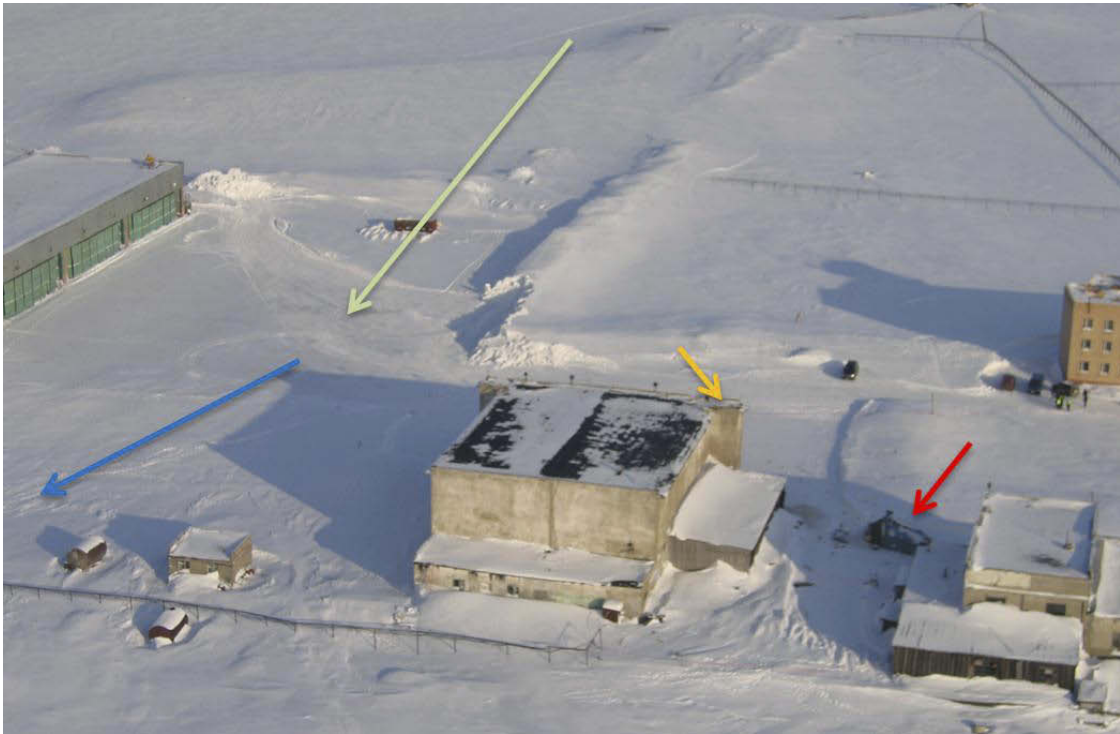
Figure 2: The heliport seen towards east-northeast. The light green arrow shows the approach direction towards the planned landing site. The blue arrow shows the planned route in the event of a balked landing. The yellow arrow marks the impact on the smallest hangar. The red arrow points to the helicopter wreckage. The picture was taken three days after the accident, after parts of the snow ridge near the landing site had been removed.

- 1.10.4 The taxiway and helipad had not been cleared of snow when the accident happened. Departures and landings therefore took place at the platform in front of the largest hangar. Most of the area between the hangars had been cleared of snow and were surrounded by snow ridges that were high in places. After the accident, a part of the snow ridge nearest to the landing site was removed (see Figure 2).

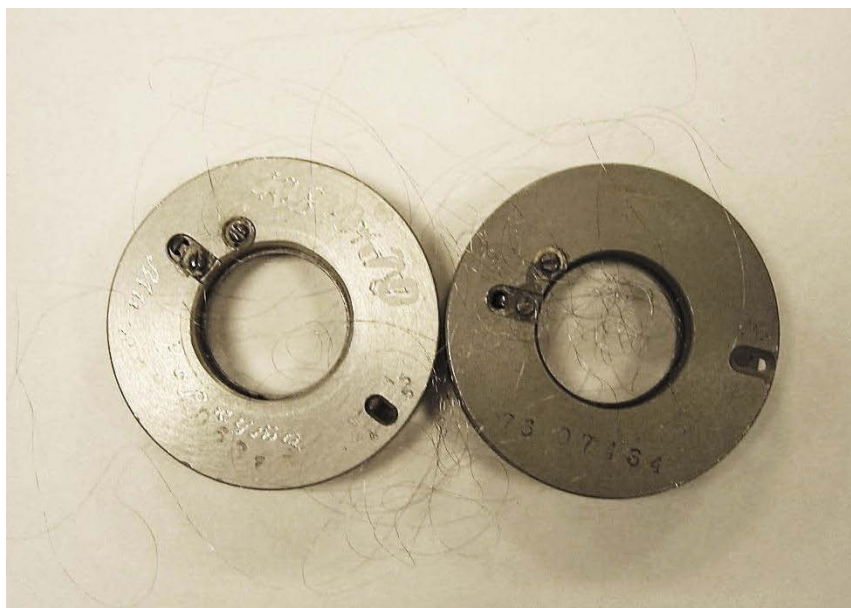
- 1.11.1.2 The six reels were sent to the Interstate Aviation Committee (IAC) in Moscow for playback. The wire on the active reel had been torn and tangled. Engineers at the laboratory were, however, able to connect the pieces properly and obtain information from the recordings. This information was useful in the investigation.

Figure 3: Two reels with tangled wire.

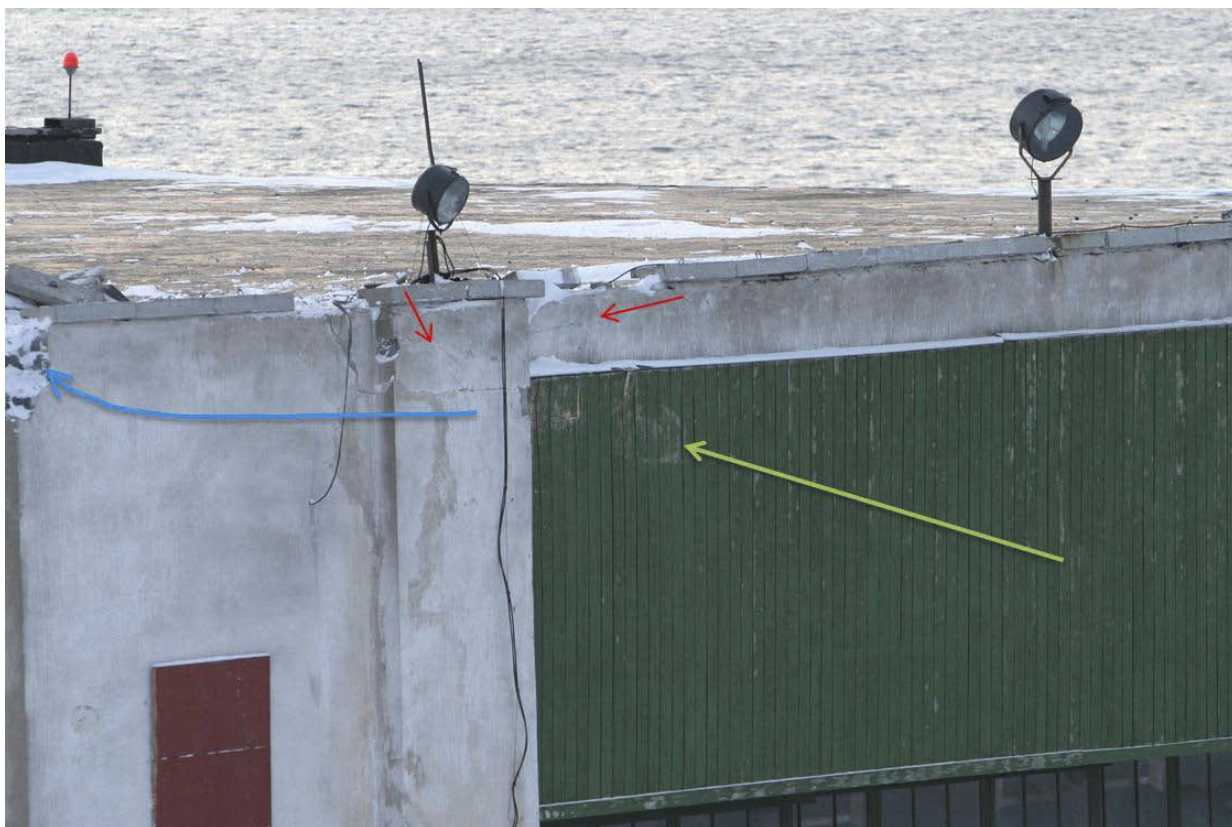
1.12.1.2 The helicopter first hit the upper south corner of the front of the smallest hangar. Clearly visible scrape marks could be seen in the green plank wall. Blue colour from the helicopter had also been scraped onto the concrete in multiple locations. Figure 5 also shows missing roof tiles and other damage to the roof, but some of this was most likely not caused by the accident. Pieces of Plexiglas were found on the hangar roof.

*Figure 5: The point of impact on the south (left) corner of the hangar. The green arrow indicates the direction from which the helicopter approached, and the red arrows show blue colour deposited on the concrete. After the impact, the helicopter continued to the left as indicated by the blue arrow.*

- 2.4.1 Based on the damage on the hangar and the helicopter, the Accident Investigation Board believes that the radome in the nose of the helicopter impacted first on the top left of the green field of the hangar (see Figure 5). As mentioned earlier, it is difficult to say anything certain about the course and sideways movement of the helicopter when it hit the hangar. The damage to the radar was limited and the Accident Investigation Board believes that the forward speed upon impact was low. Sideways movement towards the left during impact probably caused the tail to swing to the left. The helicopter must then have moved south along the hangar wall, tail first, until the hangar corner. During its passage, it did not tear down the floodlight on the roof (see Figure 5), nor did it cause significant damage to the extending concrete sections<sup>4</sup>.

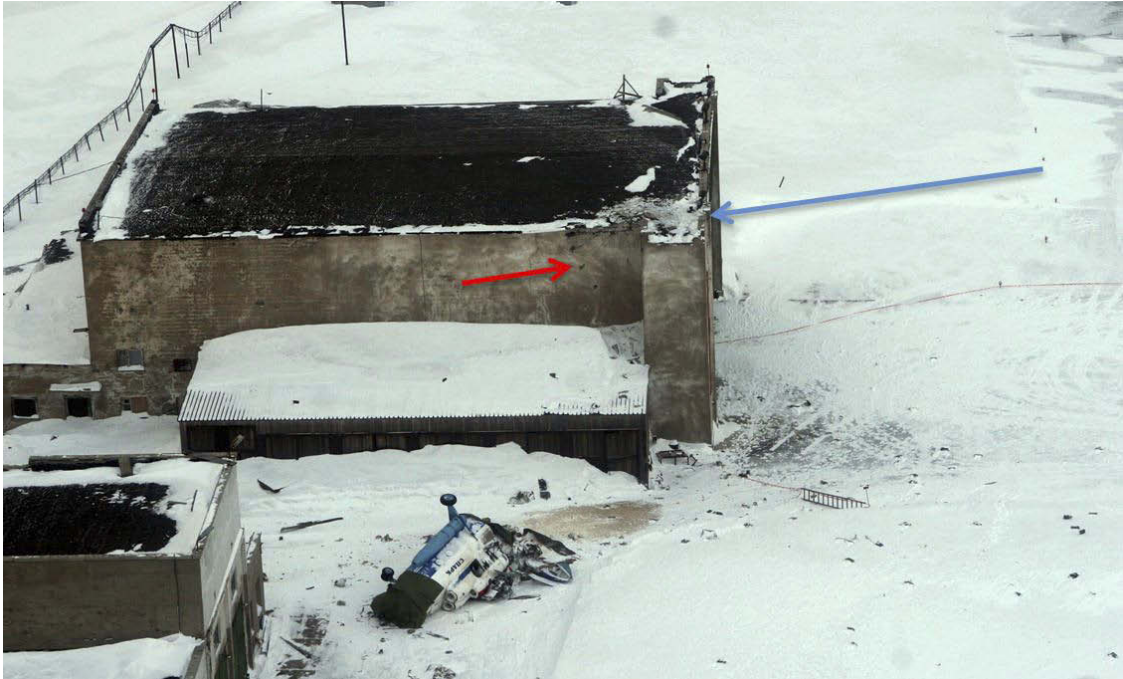
- 1.12.1.4 Figure 6 shows impact marks from the main rotor in the hangar wall. A total of six separate impact marks from the rotor can be identified. The first clear impact mark slopes approx.  $15^\circ$  down relative to the horizon, while the last clear mark points approx.  $55^\circ$  down. The helicopter did not come into contact with the underlying building which extended 9 metres from the hangar wall, but hit the ground approx. 11 metres from the extension. The helicopter wreckage came to rest on packed snow and ice, 4 metres from a garage.

*Figure 6: The hangar seen from the south. The blue arrow indicates the direction from which the helicopter approached. The red arrow shows impact marks from the main rotor in the hangar wall. The wreckage is on the ground in the foreground of the picture. Large amounts of fuel mixed with snow can be seen between the hangar and the wreckage.*

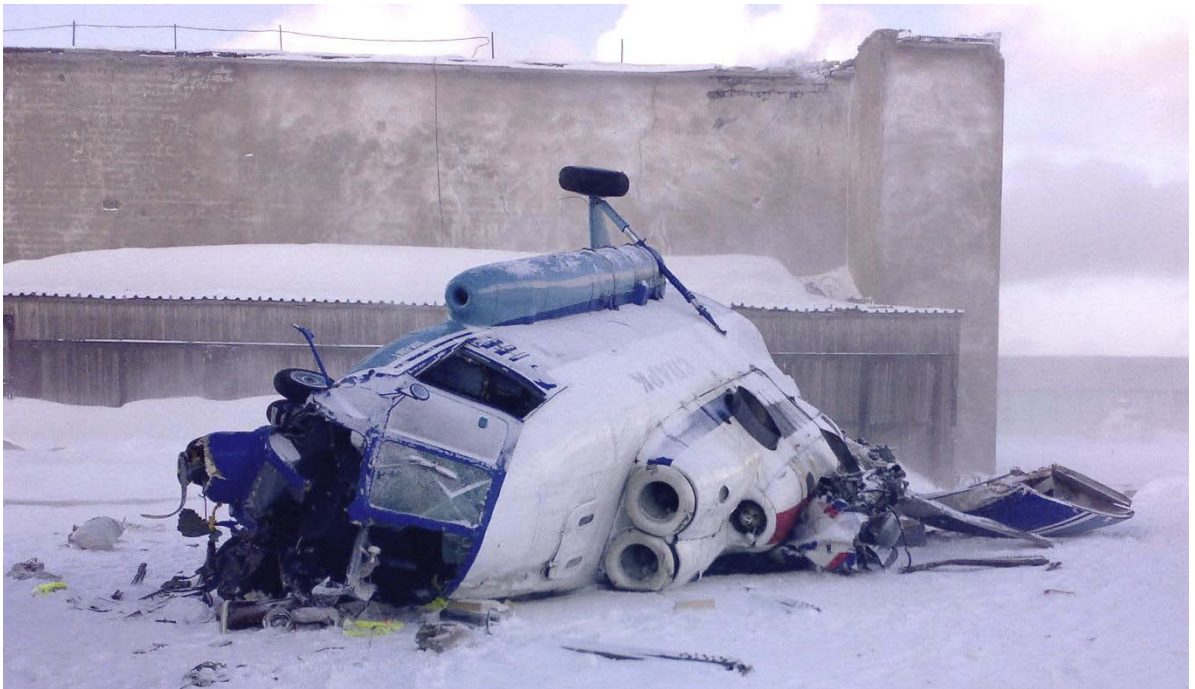
The helicopter wreckage ended up lying on the left side, mostly in one location. A number of parts, especially from the main rotor blades, had been thrown about in a radius of approx. 50 metres. Outside of this area, three larger sections of the main rotor blades were found, one lying 100 metres from the main wreckage. The damage to the helicopter was mostly limited to the front and left side of the cockpit, the main rotor, the area between cabin/cargo compartment and tailboom, as well as the tailboom.

Figure 7: Picture of the helicopter taken shortly after the accident. Note the four marked impact marks from the main rotor in the hangar wall.

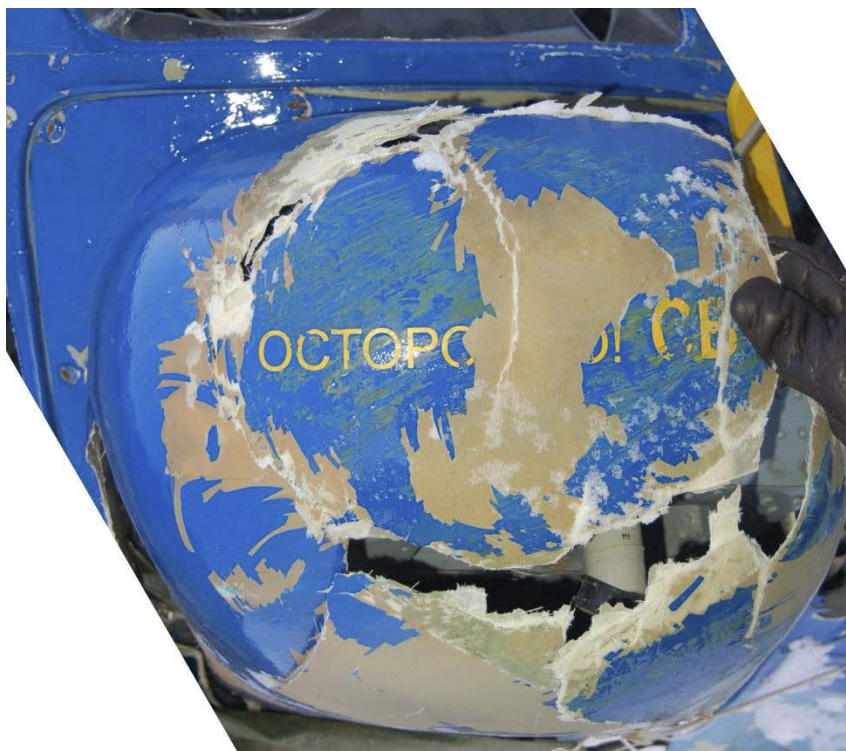
The front of the helicopter had been smashed in and parts of the radome torn off. Some parts of the cockpit were severely damaged on the left side. Several window panels on the left side of the cockpit were broken and both instrument panels had come loose and been displaced (see Figure 7 and Figure 9). There were minor traces of green paint on the front of the helicopter, corresponding to the colour on the hangar.

Figure 8: Parts of the radome had been torn off. The picture shows the dome after it was put back in place. Green paint from the hangar wall was deposited on the cover.

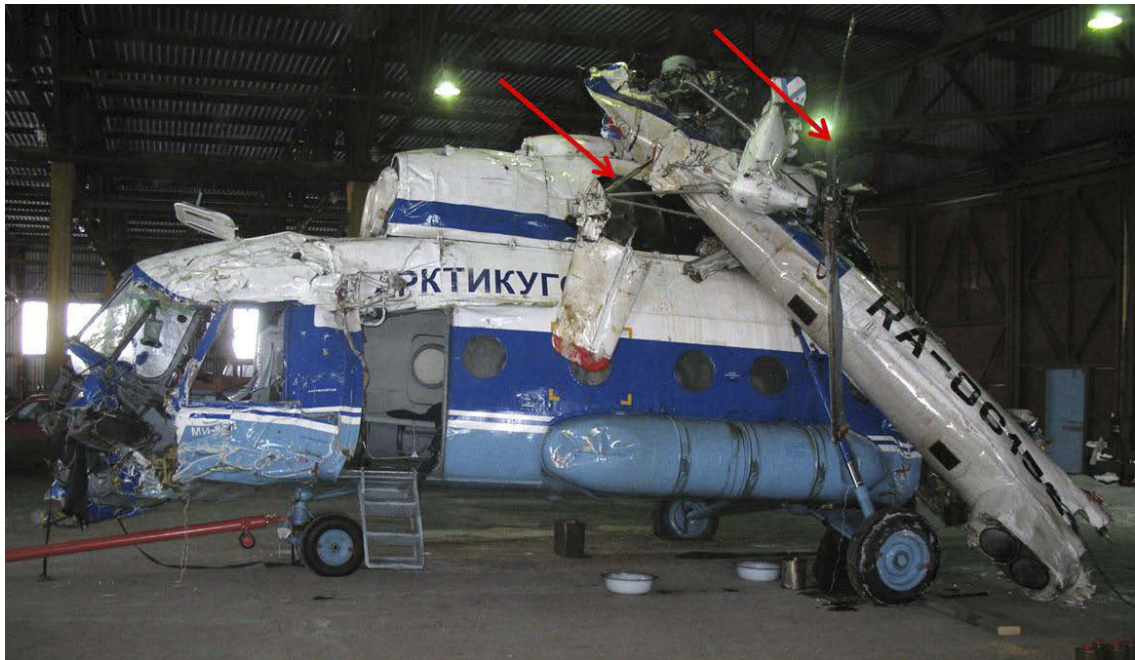
There was little damage to the tail rotor. One tail rotor blade was almost undamaged, one blade was bent in an even curve and one blade had a minor deformity. The tail rotor drive shaft had separated in the transition between fuselage and tailboom, and in the transition between tailboom and vertical fin.

Figure 9: The damage on the left side of the helicopter. The tail rotor and the undamaged support at the rear of the tailboom are marked with red arrows.

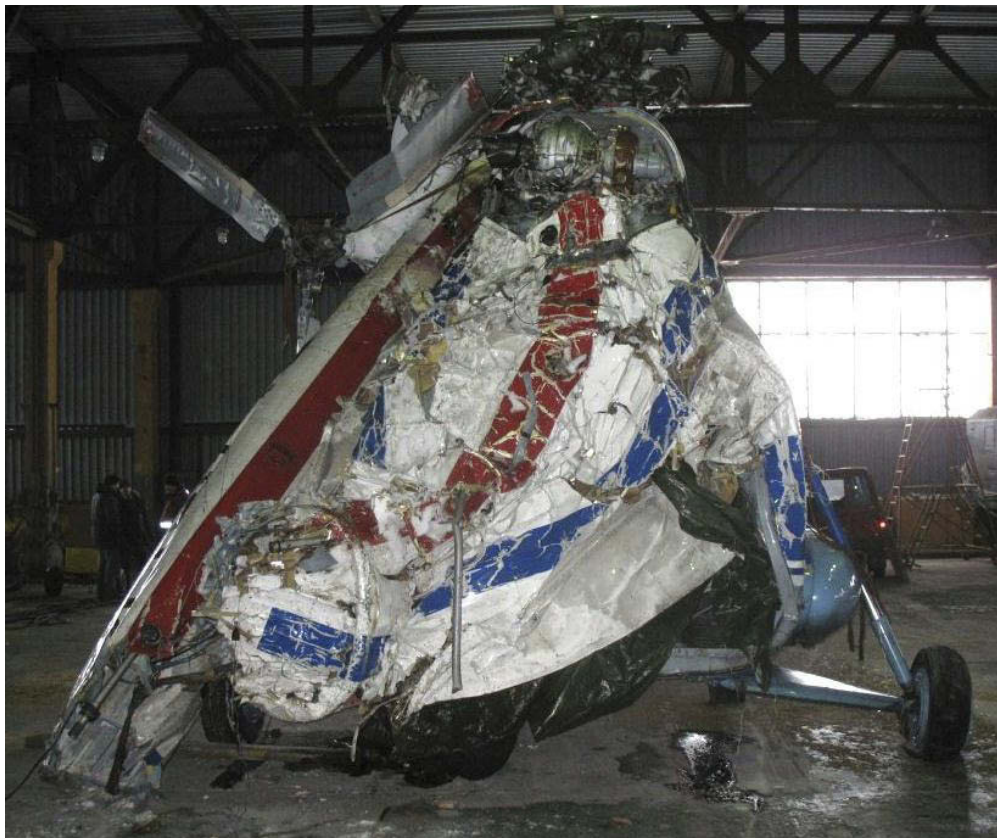
Figure 10: The damage in the transition between fuselage and tailboom. The tailboom and tail rotor on the left in the picture.

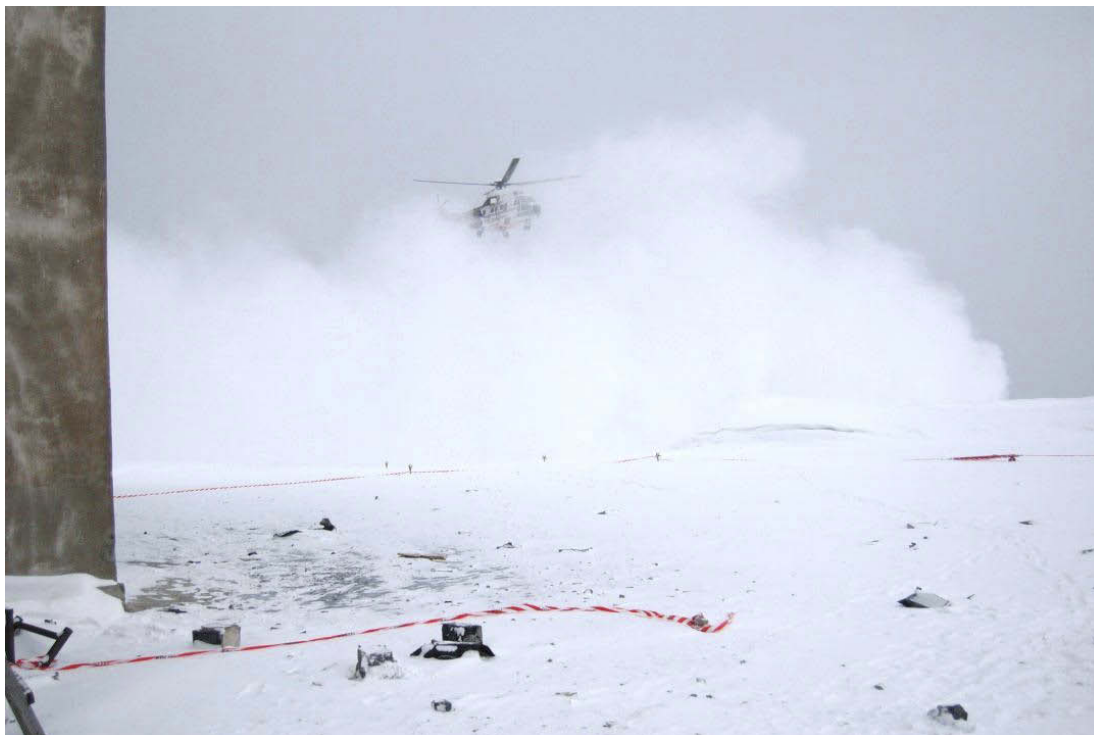
Figure 11: The Governor's Super Puma landing at the accident site. The helicopter is in high hover and blowing away the snow.
