# REPORT

## Sjø 2013/08

## REPORT ON MARINE ACCIDENT MV FULL CITY GROUNDING AT SÅSTEIN 31 JULY 2009

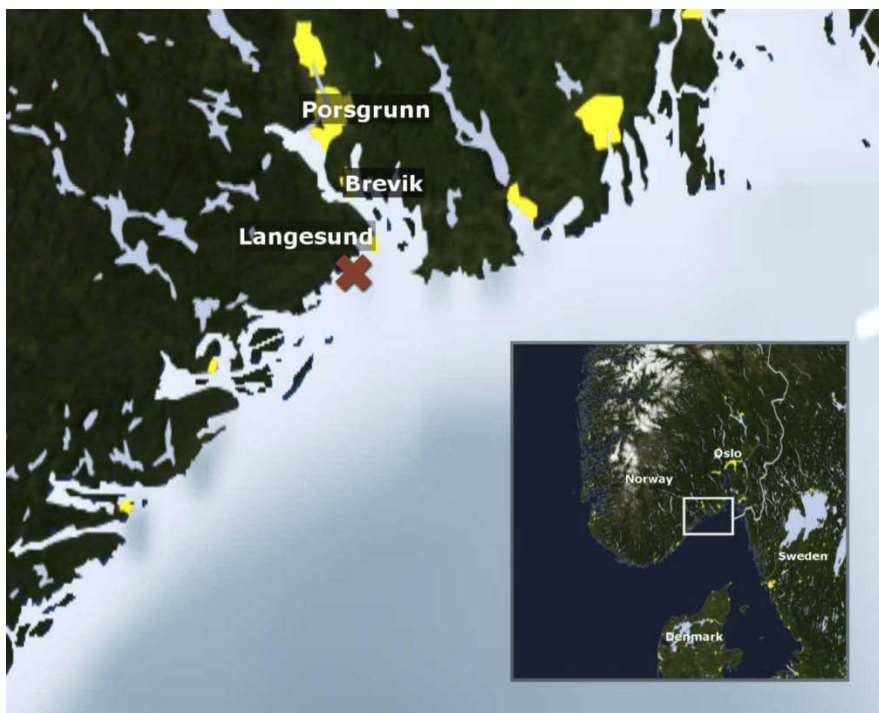
Figure 1: *Full City's* grounding at Såstein off Langesund on 31 July 2009. (Source: AIBN)

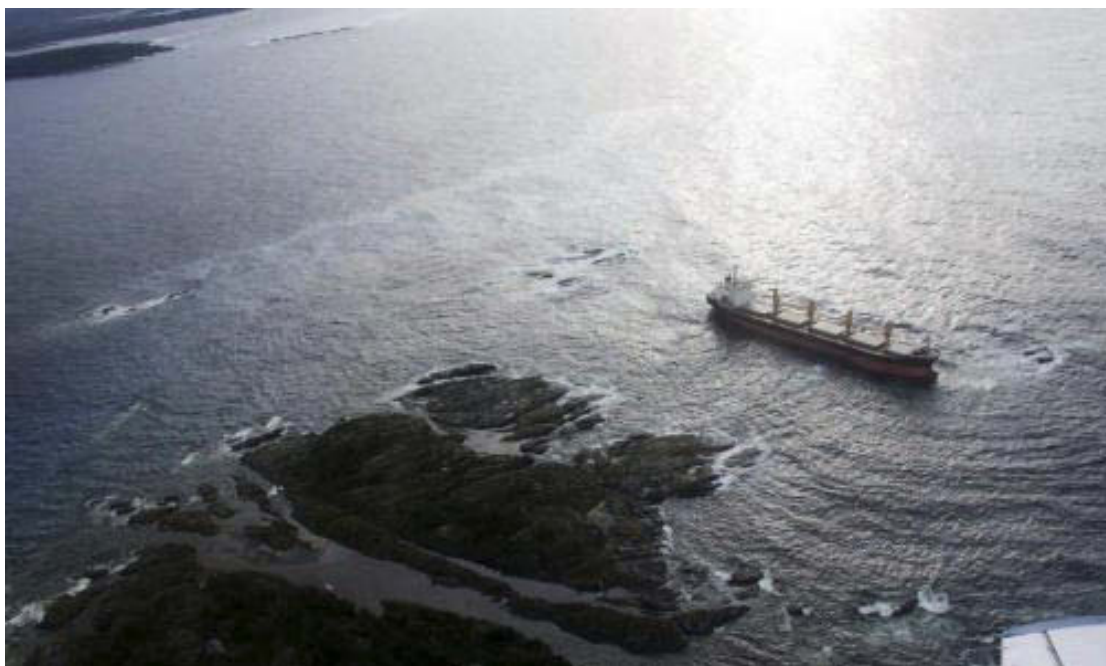
Figure 2: Full City aground east of Lille Såstein. (Photo: NCA/Scanpix).

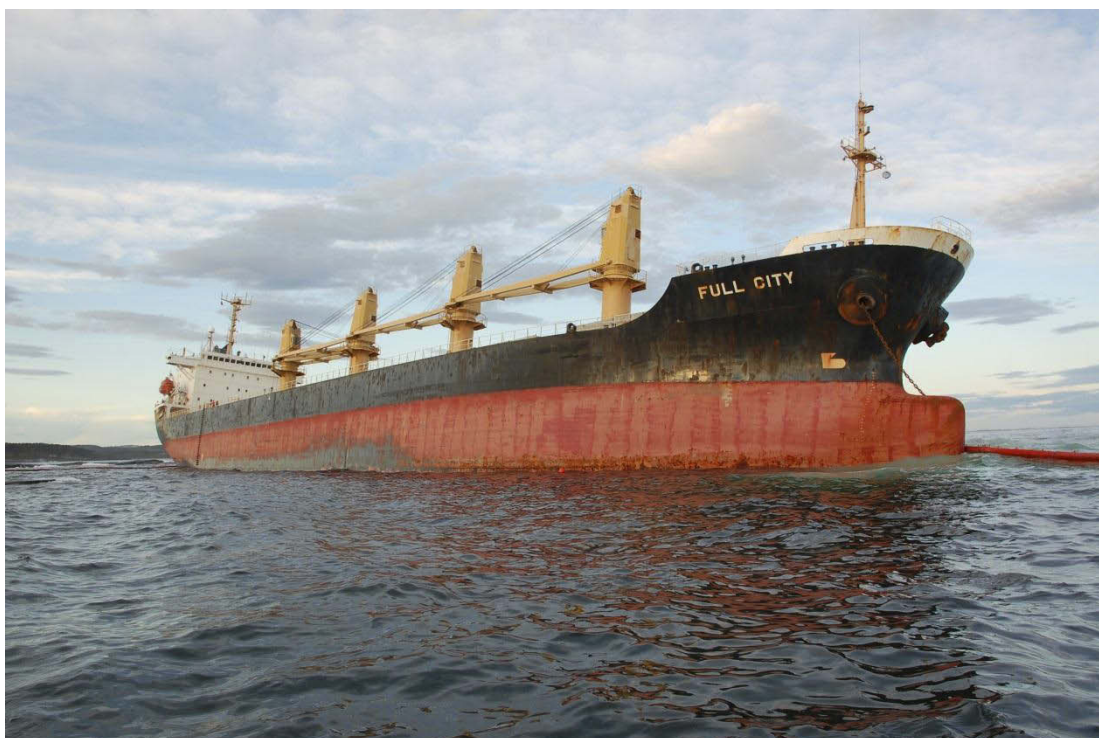
Figure 3: Full City aground at Såstein. (Photo: the police).

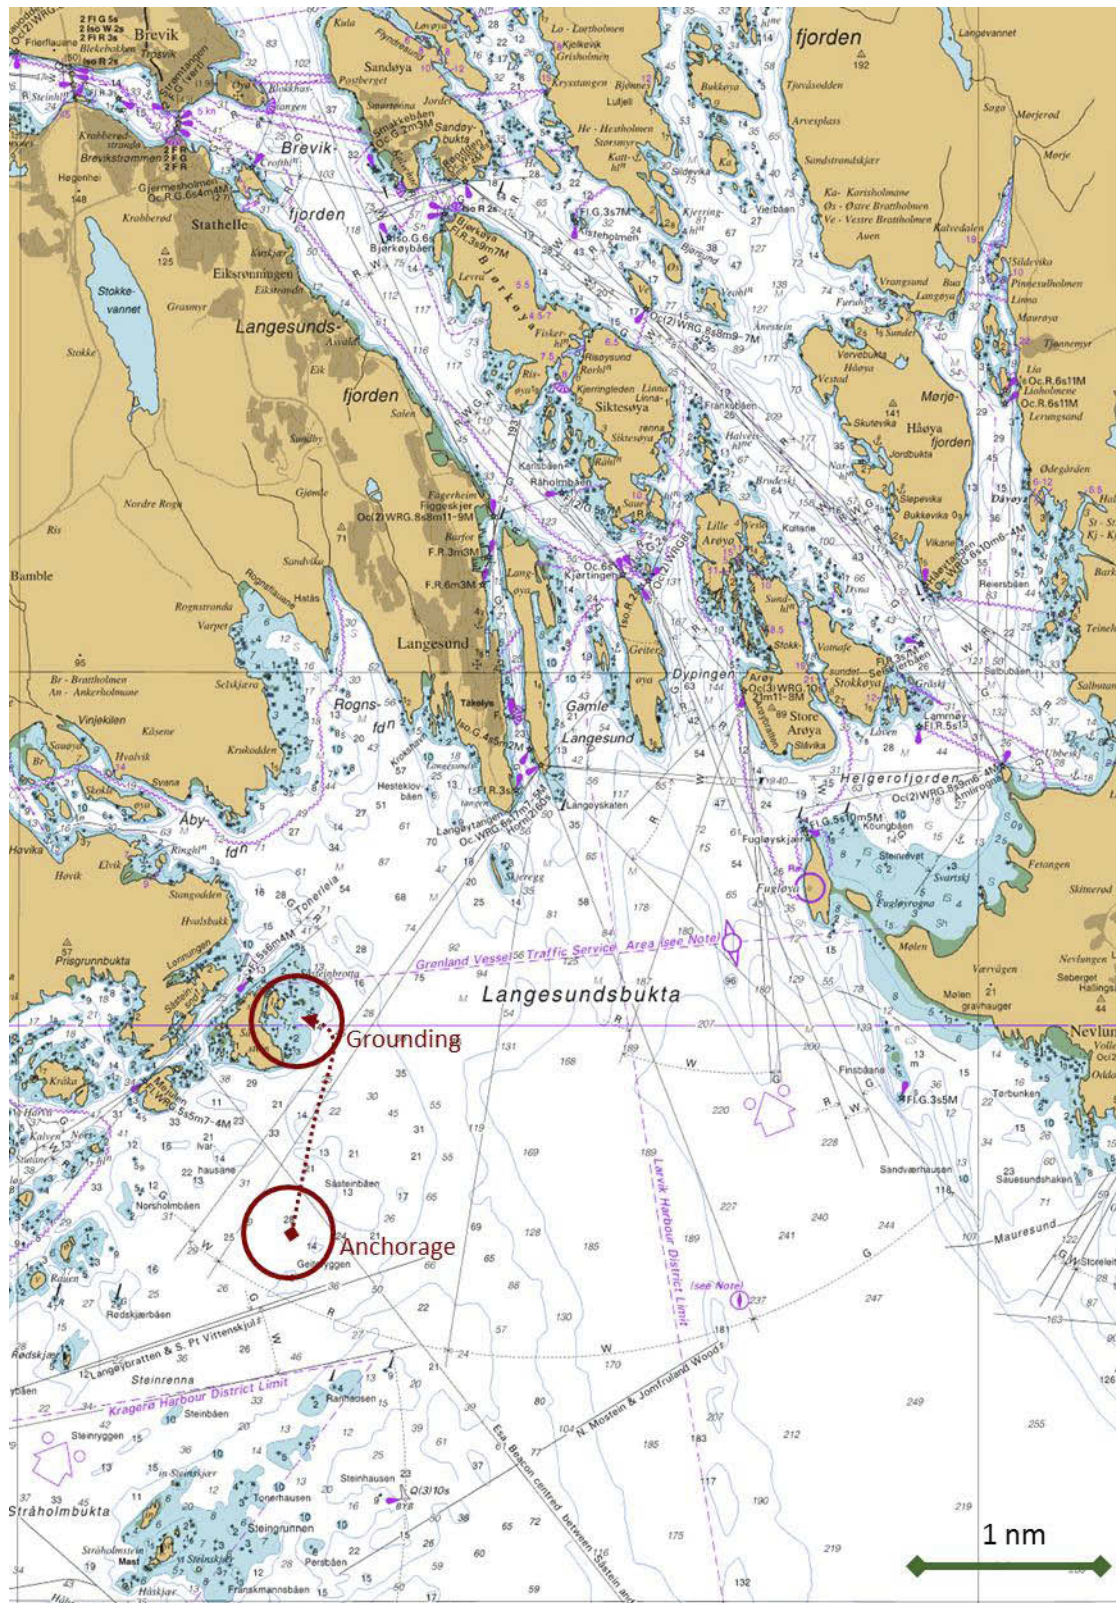
Figure 4: The position in which Full City dropped anchor, the direction in which it drifted and the place where the vessel ran aground. (Source: the Norwegian Mapping Authority/AIBN).

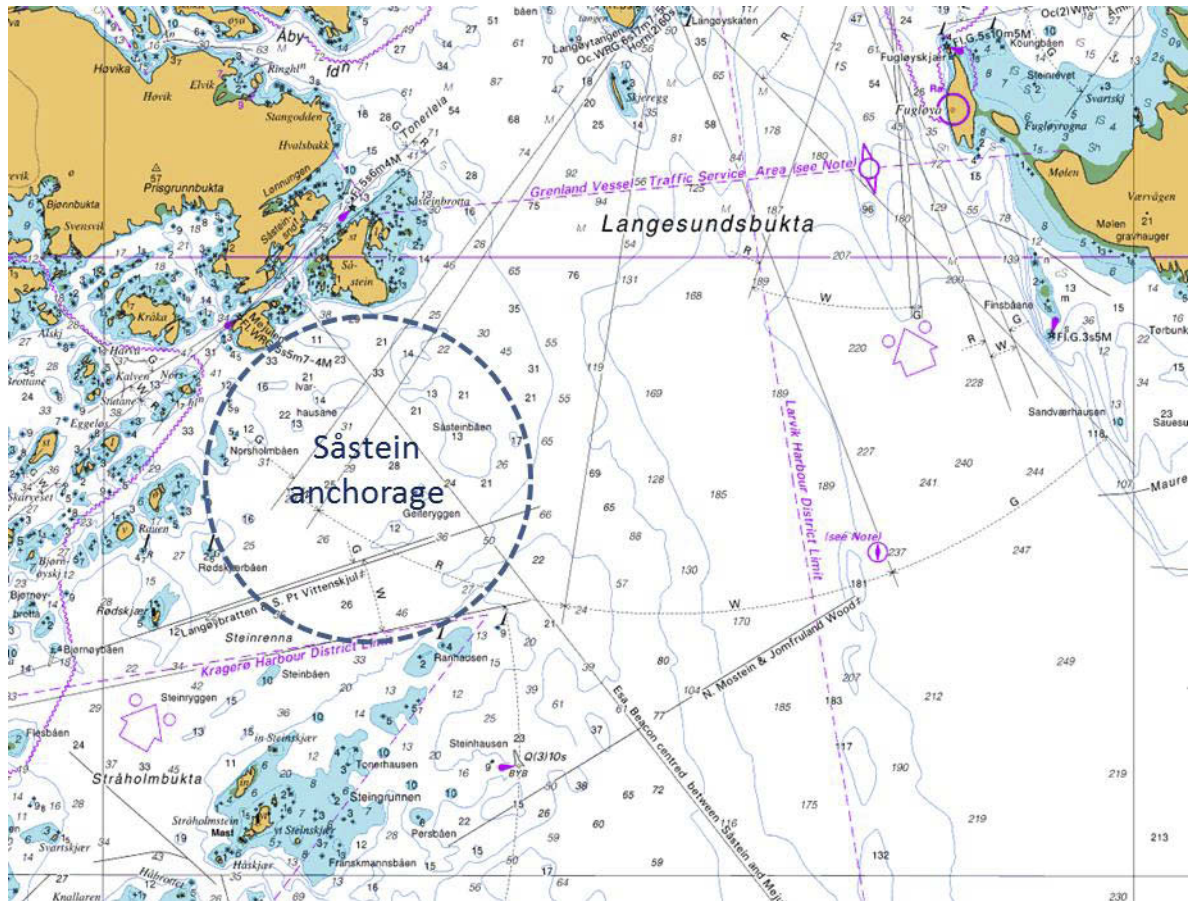
The sea area south of Såstein has been used as an anchorage for vessels waiting to berth for many years. Såstein anchorage was not marked as an anchorage area on the nautical charts. The anchorage also lay outside what was defined as the area of operation for Brevik VTS.

Figure 5: The ringed area shows Såstein anchorage. The area was not marked on the nautical charts. (Source: the NCA/AIBN).

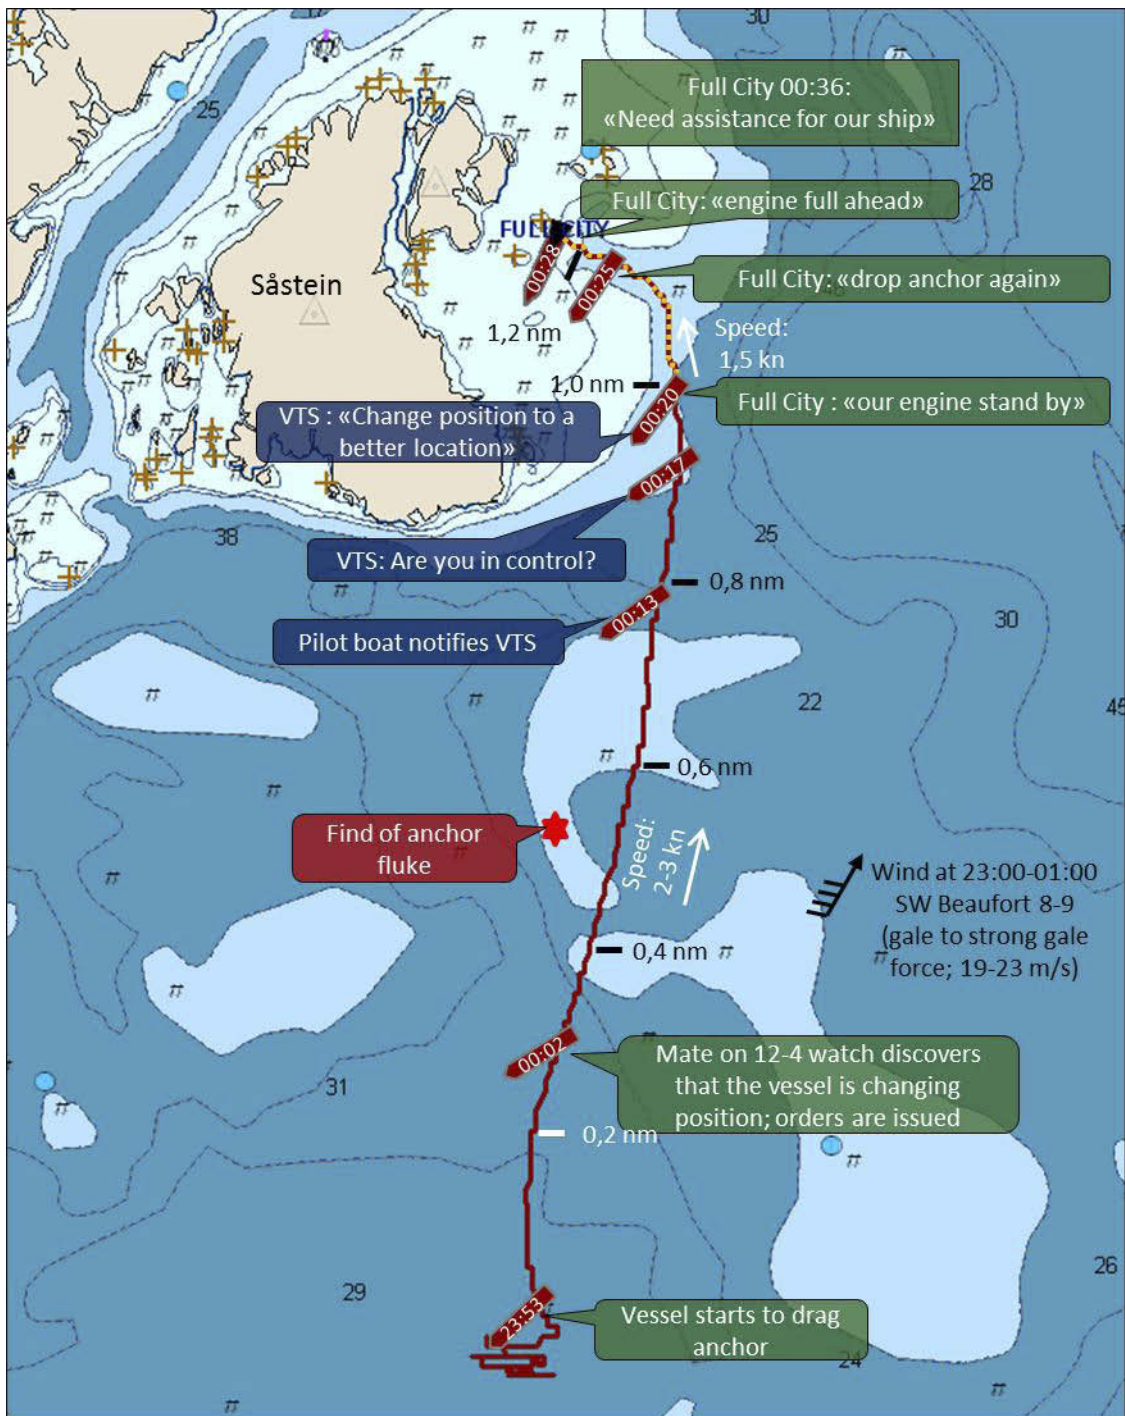
According to AIS data, the vessel started drifting from its anchor position at 23:53. One anchor fluke was found on the seabed during a subsequent search. It was found near the position *Full City* was in at around 00:10, see Figure 5. Searcharea with finding is shown in appendix A. *Full City* was then moving across a shallow seabed at a speed of 2–3 knots in a north-easterly direction. The anchor fluke was brought ashore and examined. The results of this examination are described in section 1.8.

Figure 6: AIS tracking of Full City's anchor drag, including key information. (Source: AIBN).

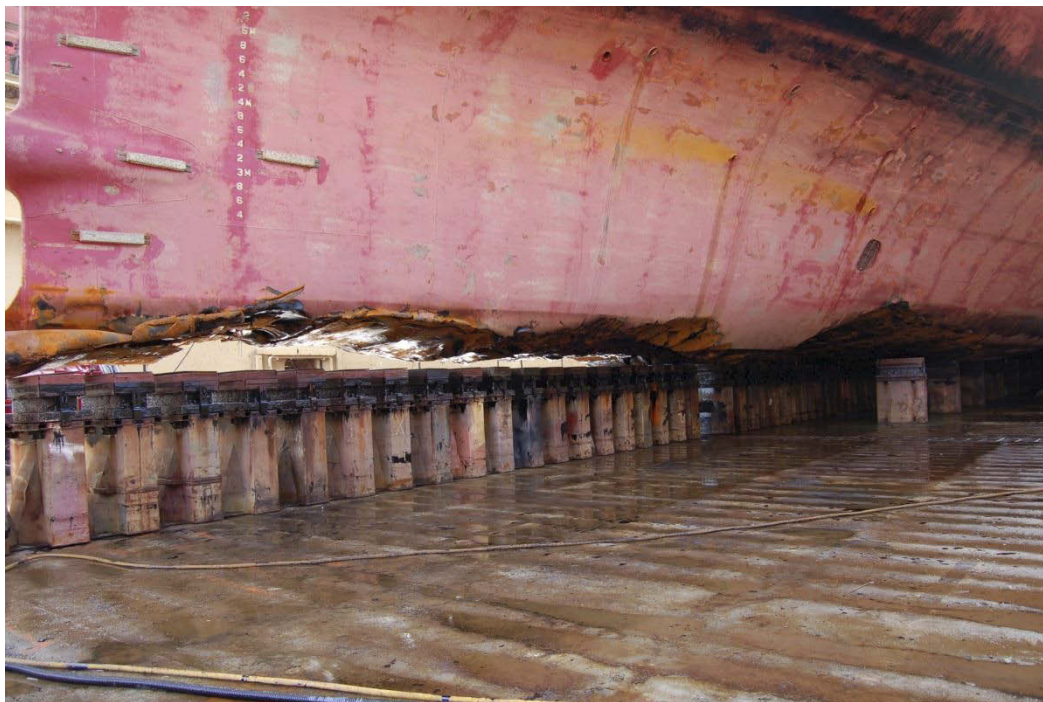
The grounding resulted in extensive damage to the hull of *MV Full City*. This caused water ingress to a large part of the engine room. The AIBN observed that there had been water up to the top of the cylinders, approximately 6 metres above the keel. There was also extensive damage to four of the five cargo holds; see Figure 7, Figure 8 and Figure 9.

Figure 7: The keel at the stern. (Photo: AIBN).

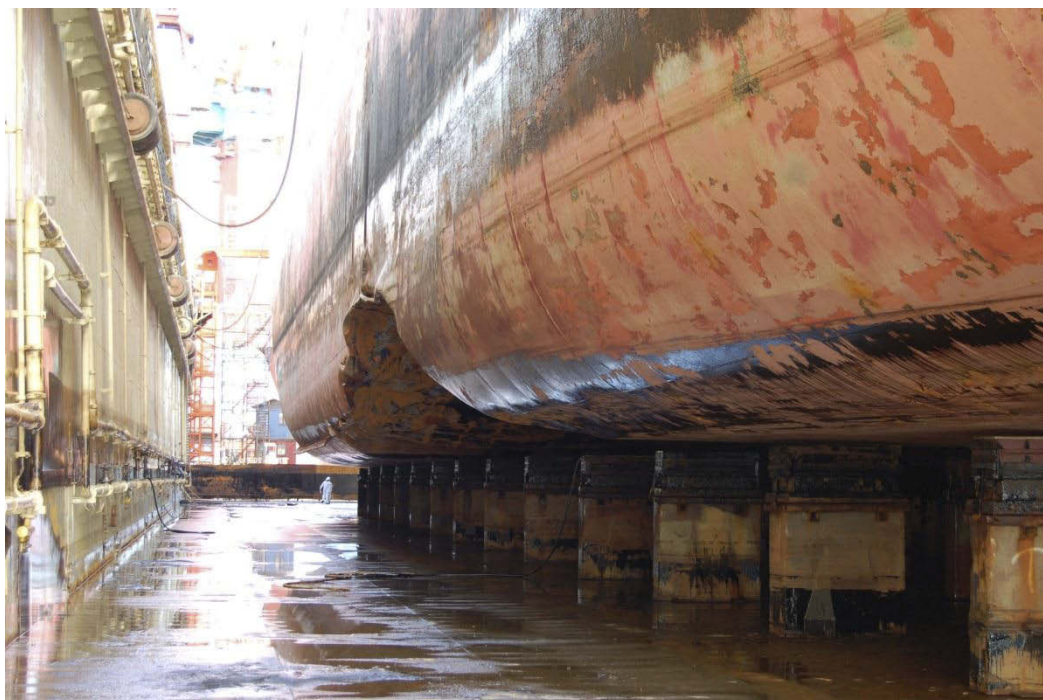
Figure 8: Damage forward of midship on the starboard side of Full City; here seen in the dry dock near Gothenburg. (Photo: AIBN).

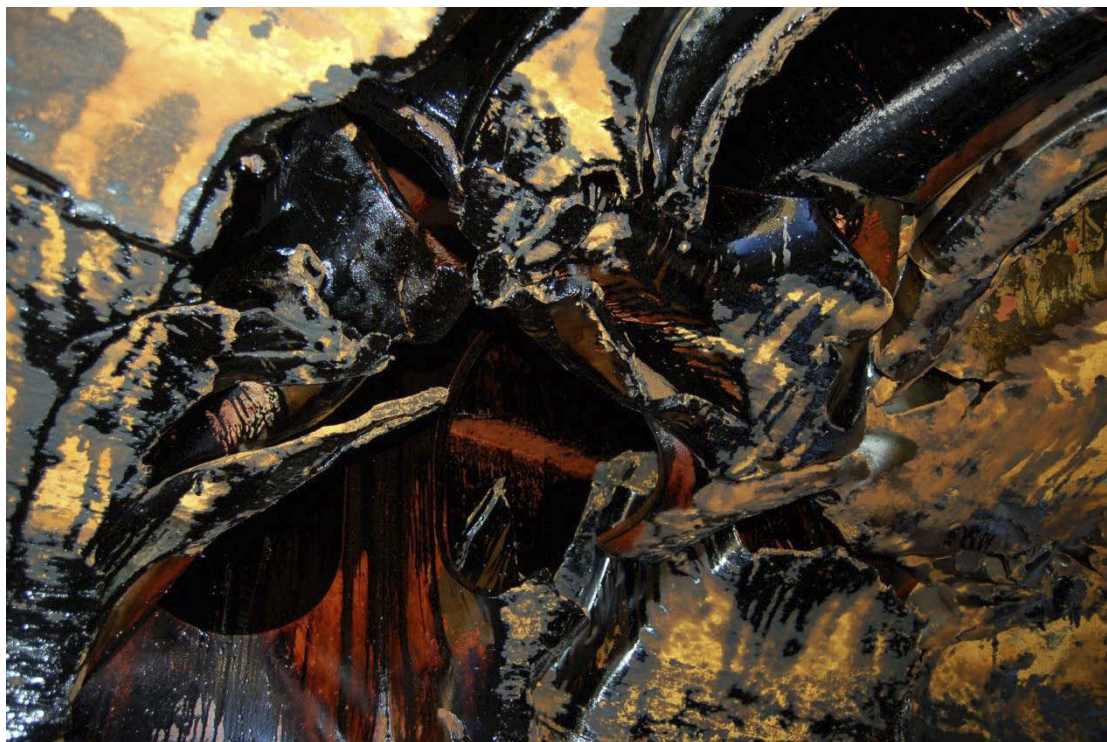
Figure 9: Hole in the bottom of Full City, with opening to the frame and tank top. (Photo: AIBN).

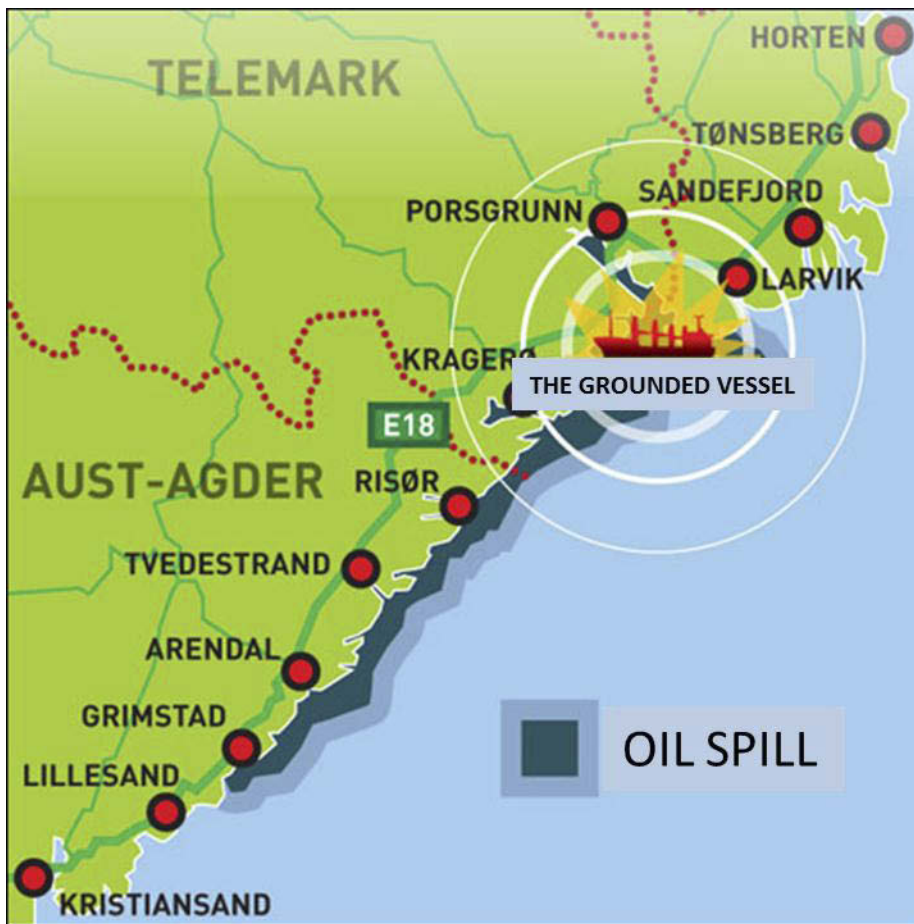
The NCA has conducted an analysis of the oil in the sea that shows how much oil can be linked to the remaining oil on board the vessel. Approximately 293 m<sup>3</sup> of oil leaked out from the vessel. This caused pollution along the coast from Larvik in the north-east to Grimstad in the south-west.

Figure 10: Illustration of the spread of the oil spill from Full City. (Source: NCA).

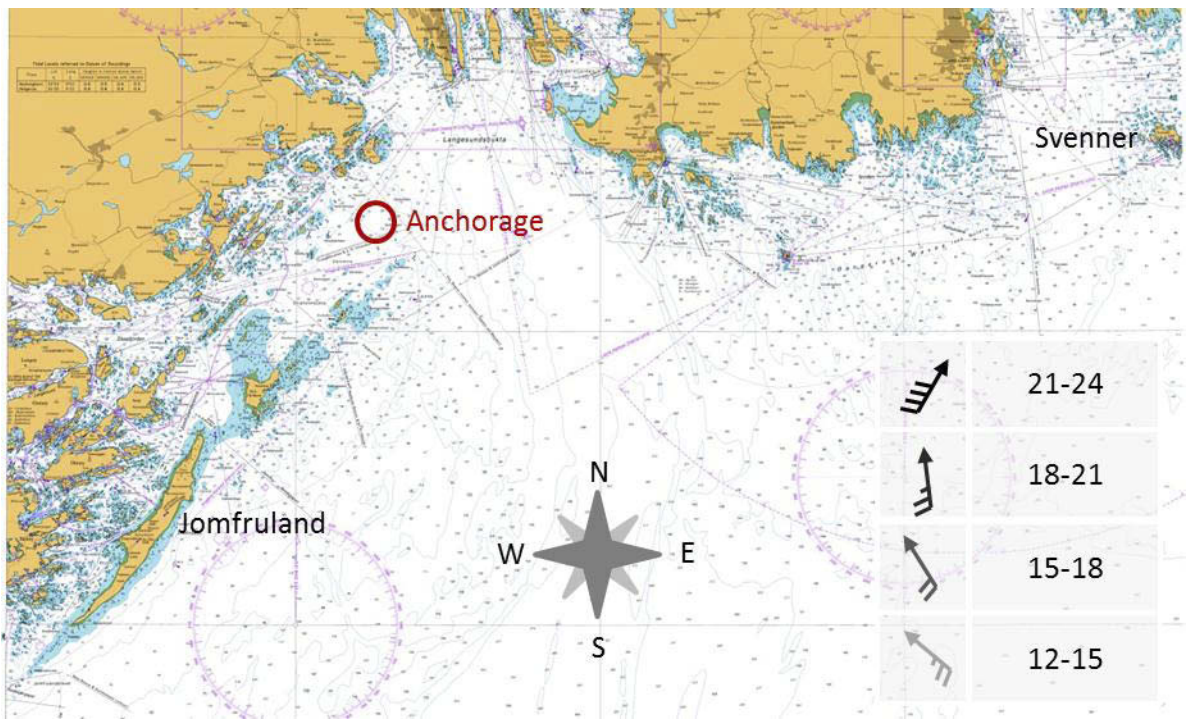
Figure 13: The anchorage's protection from the sea. The wind arrows are based on measurements at the Jomfruland and Svenner weather stations on 30 July 2009. (Source: the Norwegian Mapping Authority/AIBN).

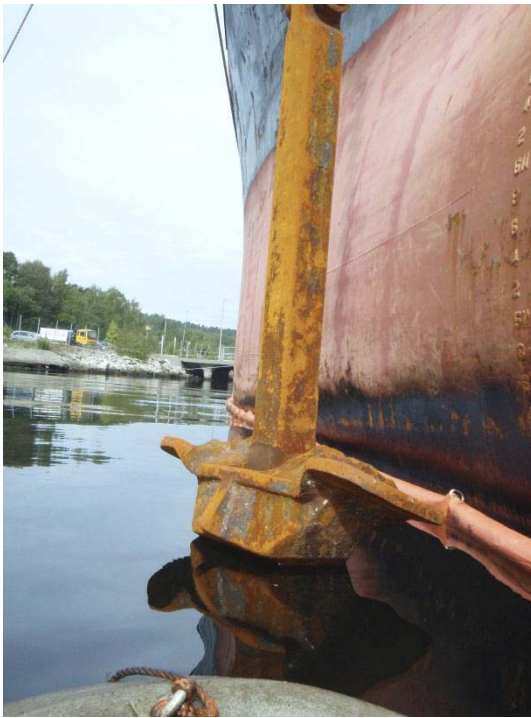
Both flukes were missing from the starboard anchor on board *Full City* after the vessel had run aground at Såstein. One of the flukes was found on the seabed near the vessel's line of drift. The fracture surfaces of both the anchor and fluke were cut out for mechanical examination at the Norwegian Defence Research Establishment (FFI) at Kjeller, and isotope photography (radiographic examination) at Nammo in Raufoss. None of the examinations carried out at FFI and Nammo detected any anomalies in the strength or quality of the damaged anchor.

*'The starboard anchor winch and brakes were functional during the test. The starboard anchor chain has withstood the loads to which it was exposed and did not break. The starboard anchor dragged and both anchor flukes broke off.'*

Figure 14: Starboard anchor without flukes. (Photo: AIBN).

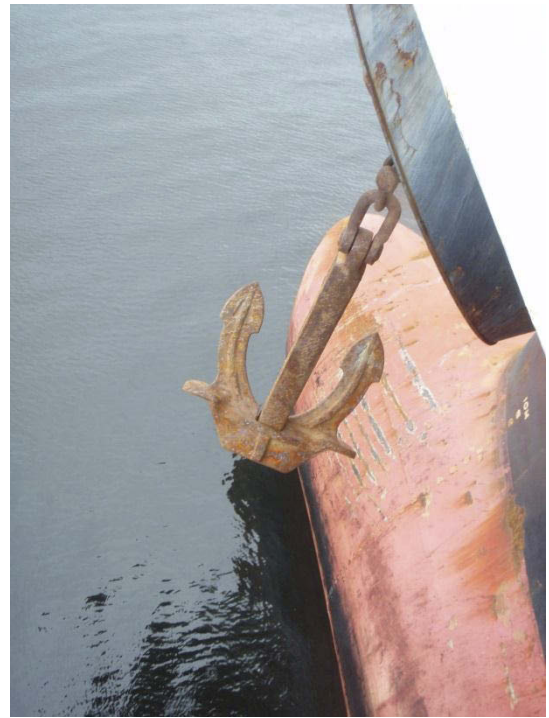
Even though only the starboard anchor was deployed when the vessel lay at anchor, DNV also tested the port anchor system. The test demonstrated that the port anchor system worked as intended.

Figure 15: Intact port anchor. (Photo: AIBN).

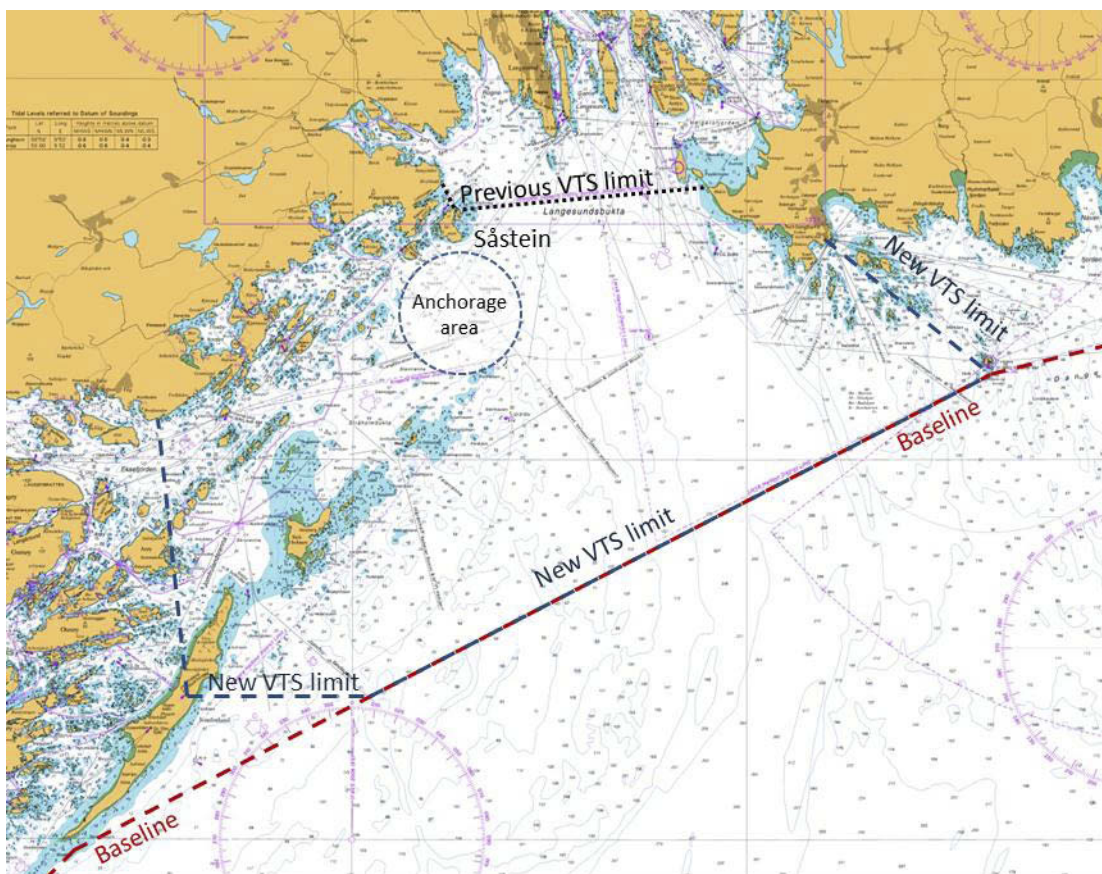
Figure 22: Expansion of Brevik VTS's area of operation, applicable from 1 January 2010. (Source: NMA/AIBN).

The NCA states that an expansion of Brevik VTS's area of operations means that vessels will be required to ask for permission pursuant to Section 15 of the Maritime Traffic Regulations before sailing into or anchoring in Langesundsbukta. The expansion also means that the VTS centre will have the authority to stipulate conditions for sailing in Langesundsbukta and for the use of, for example, the anchorage at Såstein. And finally, the expansion also means that the VTS centre will be able to establish information, traffic organisation and navigation assistance services in Langesundsbukta.

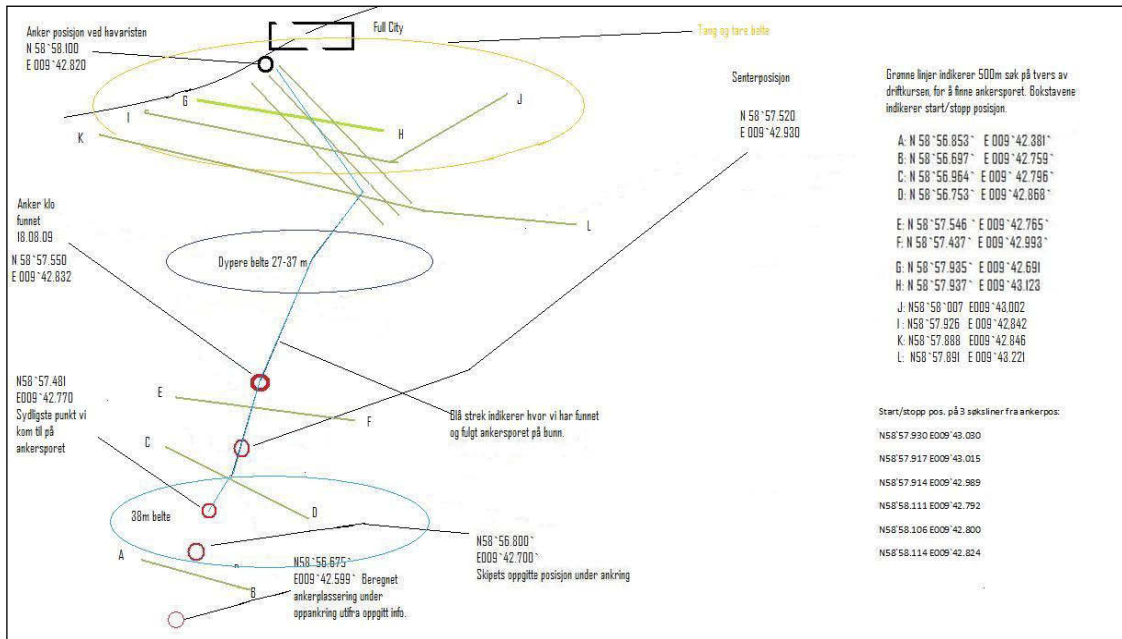
Searcharea on the seabed and determination of findings (source: Norwegian navy divers)
