# REPORT

## Sjø 2013/08

## REPORT ON MARINE ACCIDENT MV FULL CITY GROUNDING AT SÅSTEIN 31 JULY 2009

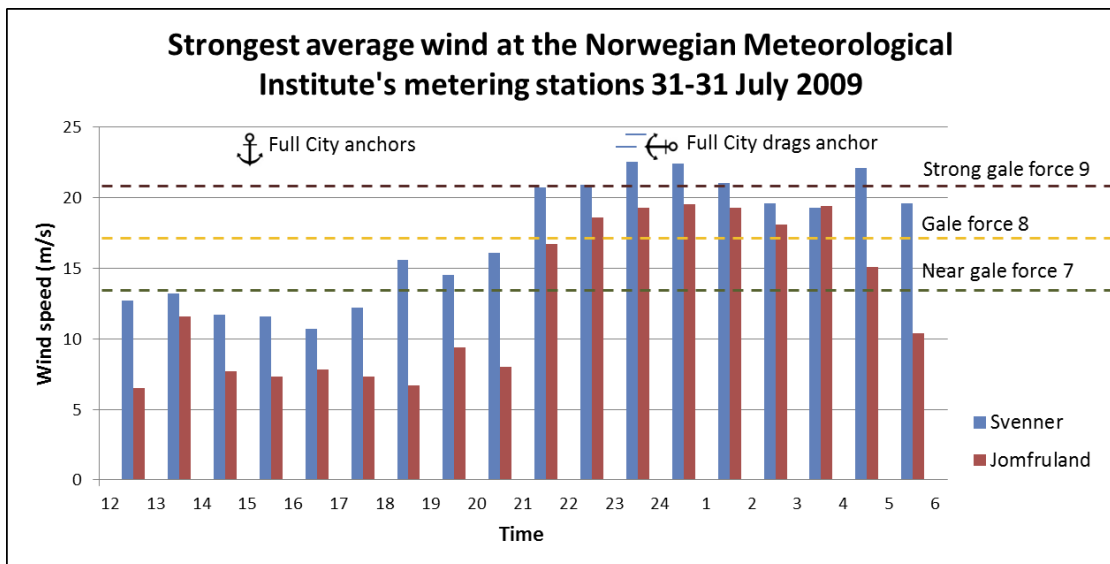
Figure 12: Observations of ten-minute maximum mean wind speeds at hourly intervals (Source: NMI/AIBN).

The AIBN has also received more detailed hour-by-hour wind data from the Norwegian Meteorological Institute. The figure below shows how the wind developed around the time of the accident.

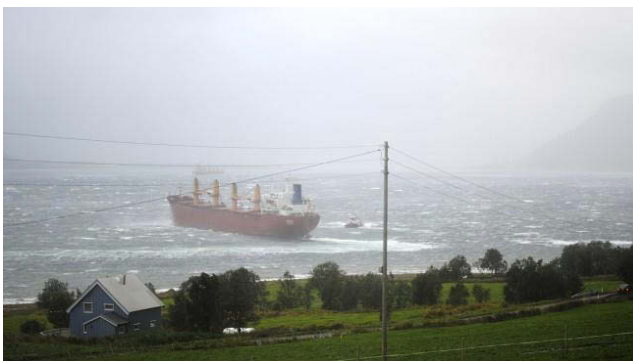
Figure 18: *Yamaska* being pointed into the wind and pushed seawards by the tugboat *Boa Hårek* off Nesna in 2009. (Photo: NRK/Lena Kristin Vollen).

On 9 September 2009, *MV Yamaska* (BT 16 623) lay at anchor at Nesnaflaket in Nordland county together with two other ships. The vessel was in ballast condition and had approximately 220 m<sup>3</sup> of bunker fuel on board. According to the NCA, there was a south-westerly gale at 07:45 when the tugboat *Boa Hårek* overheard one of the other two vessels at anchor calling *Yamaska* on the VHF channel, notifying it of a danger of collision. *Boa Hårek* notified Vardø VTS of the situation at 07:50, and Vardø VTS gave *Boa Hårek* orders to proceed to the position in question and remain on standby, as the risk of the vessel drifting ashore was considered to be high.

The navigation officer in charge on *Boa Hårek* has estimated that, at the closest point, *Yamaska* was approximately 280 metres from the nearest shore and approximately 90 metres from the 5-metre contour.

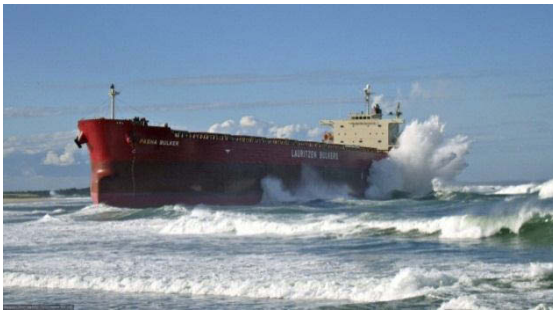
Figure 19: *Pasha Bulker* grounded near Nobbys Beach in Australia. (Source: [masterok.livejournal.com](http://masterok.livejournal.com)).

The wind was south-easterly and increased to fresh gale after midnight, and at 05:00, the wind increased to strong gale (force 9) with wave heights of 4–6 metres. At 06:25, the vessel started dragging. The master managed to heave the anchor when the vessel was 1.2 nm from shore, but the attempt to turn the vessel into the wind failed, and it grounded on the lee shore at 09:51 (see Figure 19). The hull was holed, but the grounding caused no pollution.

The Australian Transport Safety Bureau (ATSB) (Marine Occurrence Investigation Report No. 243), which investigated the incident, believed that several unfortunate decisions on board in the attempt to get out of the situation contributed to the vessel running aground. A survey that was conducted found that most masters, including the one on *Pasha Bulker*, expected clearer guidance from the VTS centre as to when it was no longer safe to remain at anchor.

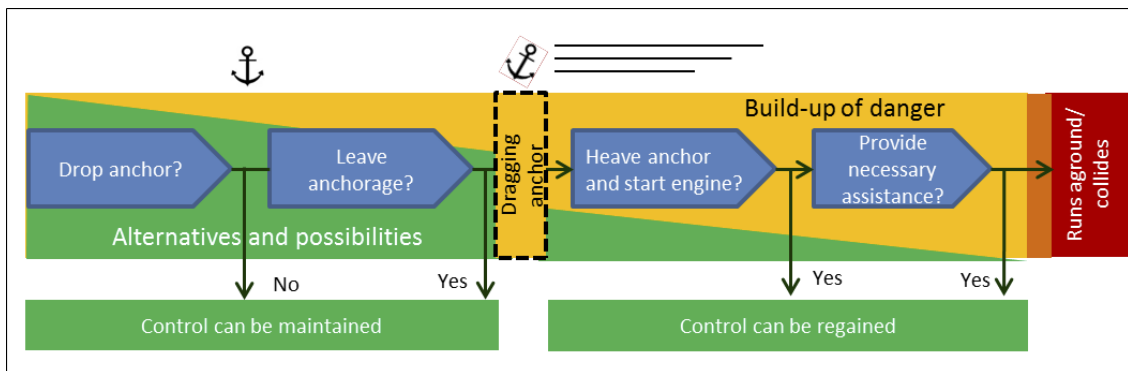
The accident shows that time was scarce from when the vessel started dragging anchor until it ran aground at Såstein. Other incidents cited in this report also show that large vessels may find it difficult to deal with anchor dragging in rough weather, even if they have more time available. The adverse weather that developed during the night and in the early hours of 31 July 2009 had been forecast for several days. The AIBN believes that grounding is best avoided by assessing the conditions in advance. When the vessel entered Norwegian waters on 30 July, the plan was to berth at Herøya on the morning of 1 August. The vessel had to wait for almost two days, and no alternative to Såstein anchorage was considered, despite of the anchorage being exposed to the forecast weather.

Figure 23: Timeline illustrating that the possibility of avoiding grounding as a result of dragging anchor is greatest during the early phase, before a vessel starts dragging. (Source: AIBN)

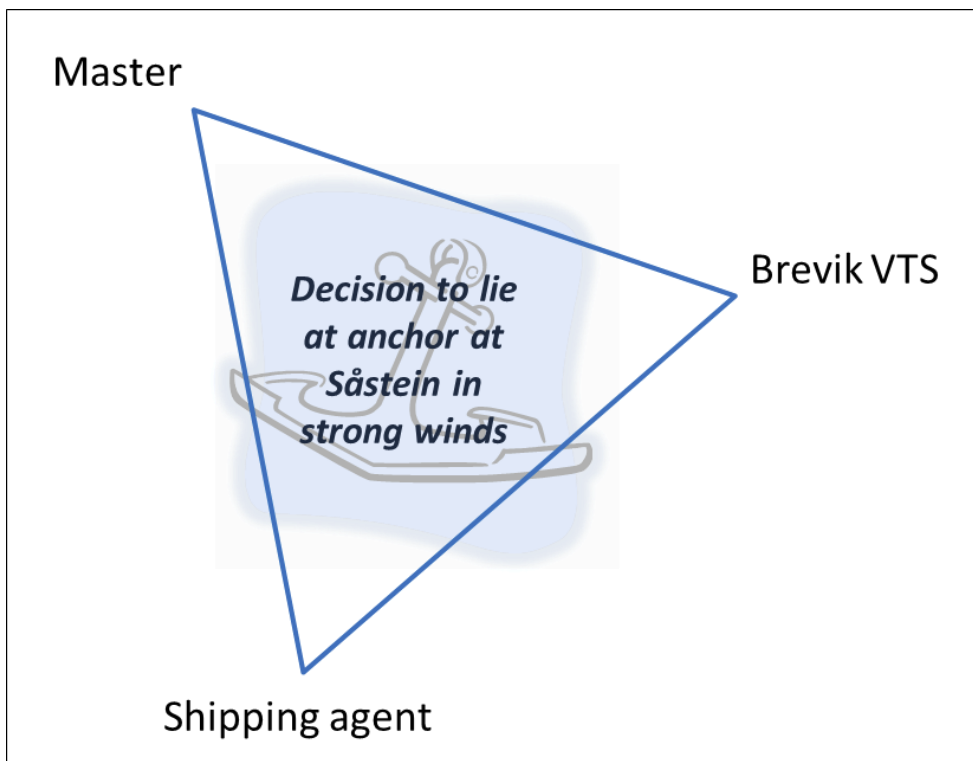
Great wind and wave forces caused *Full City* to lose its anchor hold, drag anchor and run aground at Såstein. The AIBN's assessments of the chain of events show that the greatest potential for safety improvements relates to the decision to anchor. The investigation has shown that three parties mainly influenced this decision.

Figure 24: The decision to anchor as the result of interaction between three parties. (Source: AIBN)

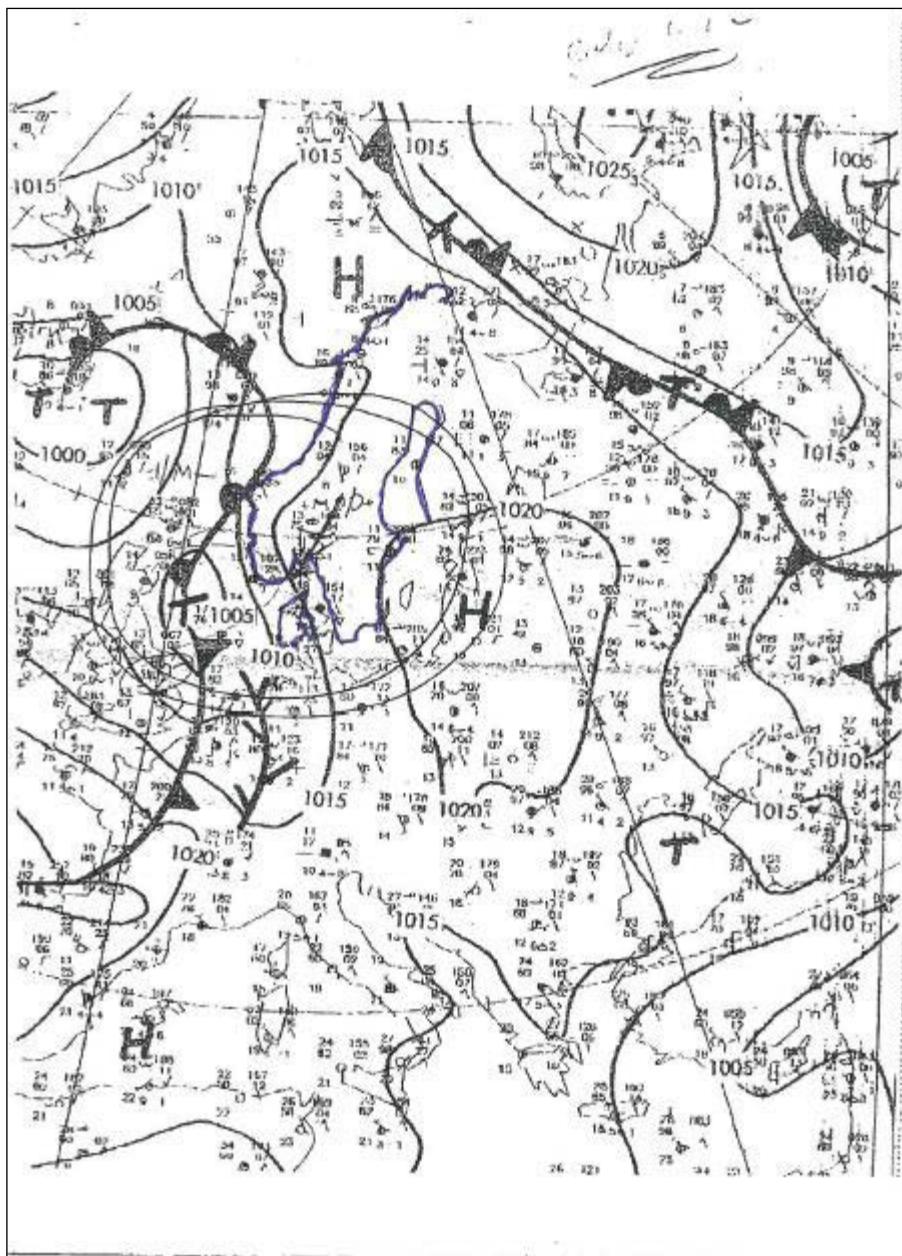
The weather forecast also includes a hydrographic chart showing areas of high and low pressure. The master and one of the mates noted that there were low pressures down to 1 005 mb on the chart and that this could generate strong local winds. The chart showed 1 005 mb approximately in the middle of the North Sea. Hydrographic chart dated 30.7.2013 at 11:00 (local time) is shown in appendix C.

Hydrographic chart of Europe of 30. July 2009 at 0900UTC (source: Detcher Wetterdienst)
